Abschlussbericht DFG-Re 2653/1-2

1.3	Institut/Lehrstuhl	Karl-Winnacker-Institut der DECHEMA e.V. Theodor-Heuss-Allee 25 D-60486 Frankfurt am Main
1.4	Aus DFG-Mitteln bezahlte wissenschaftliche Mitarbeiter/ innen mit Angabe des Beschäftigungszeitraums	Dr. M. Rudolphi 01.02.2007 - 31.01.2009

1.5	Thema des Projekts	The Role that Hydrogen and Sulfur Play in Desktop Failure of Thermal Barrier Coatings
1.6	Berichtszeitraum Förderzeitraum insgesamt	01.02.2007 - 31.07.2009 01.02.2007 - 31.07.2009

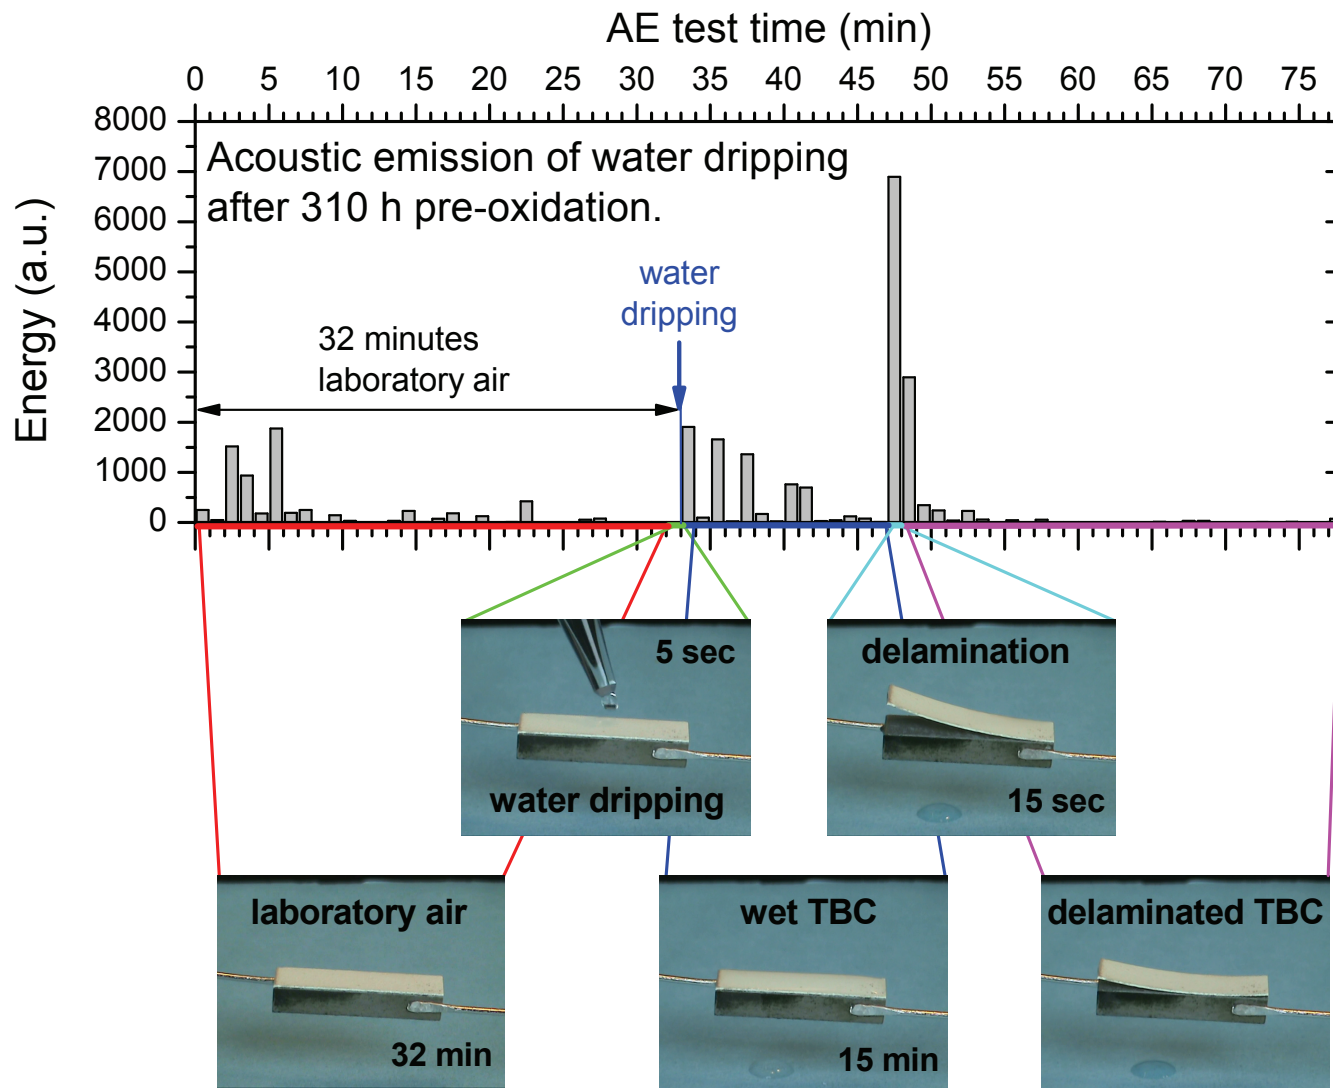
Figure 6:

In order to reproduce this result a series of oxidation experiments with EB-PVD TBCs were designed which incorporated acoustic emission technique as well as video capturing to correlate the soundwaves from the cracking with visible spallation [19]. The sample was isothermally pre-oxidized at 1050 °C in laboratory air for 310 h, then removed from the furnace and quenched to room temperature within 5 minutes. Subsequently the acoustic emission equipment was connected and the subsiding of cracking due to thermal expansion mismatch stresses was monitored. After 30 minutes distilled water was dripped onto the cold TBC. Still images from the video clip and the correlation between acoustic emission and visible spallation are given in figure 6. A copy of the video clip is on the enclosed CD-ROM. As can be seen from figure 6, the acoustic emission increased immediately after the water was added, the TBC started to delaminate about 15 minutes afterwards. Complete delamination was achieved within about 15 seconds.

Acoustic emission of 310 h pre-oxidized sample (1050 °C) and video still images from the monitor camera at certain points in time. The sample was quenched to room temperature prior to connecting the AE sensors and monitored for 32 min before water was added.

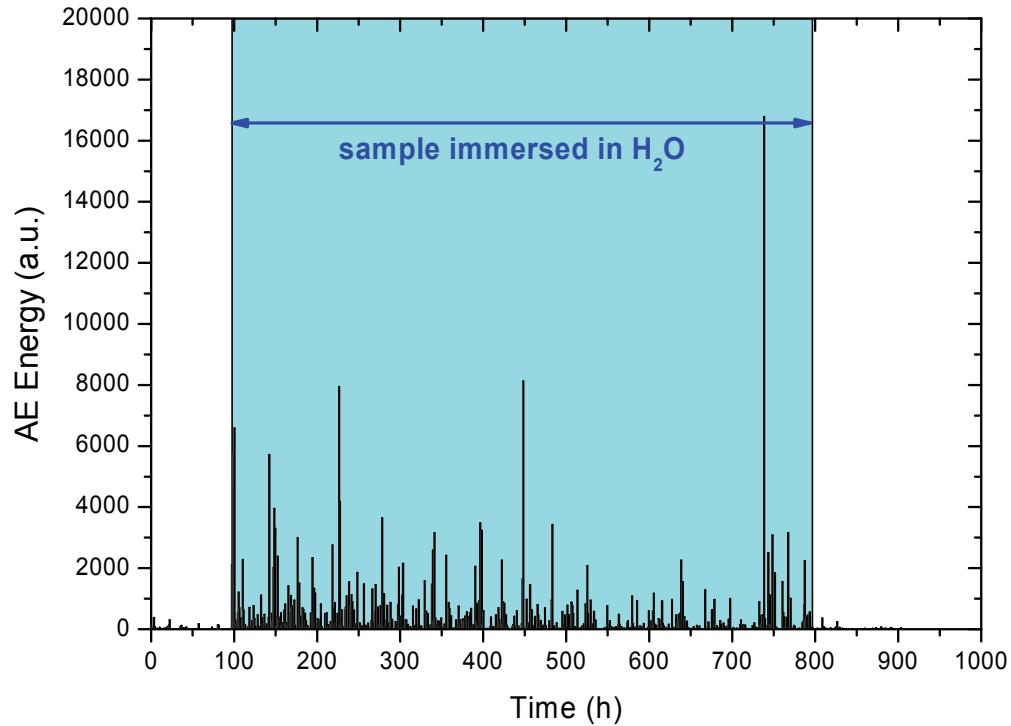
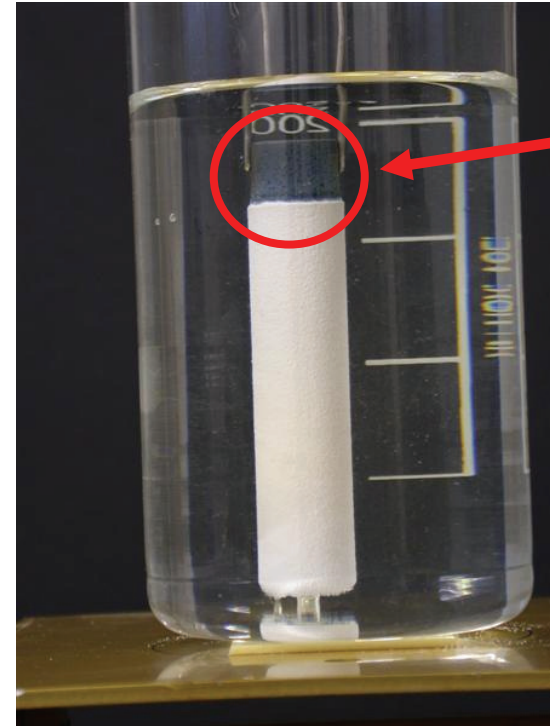
Figure 8:

8a). The sample remained submerged for about 700 h and the acoustic emission continued at an increased level for the length of the immersion; however, the sample did neither spall nor show any visible cracks in the TBC. Upon removing of the sample from the water beaker the acoustic emission subsided and reduced to an amount similar to the noise recorded prior to the water immersion. Unfortunately, the uncoated part of the sample was also immersed in water during the test leaving the possibility that the recorded sound waves might have originated from the exposed oxide scale. Consequently a second experiment was conducted to investigate this possibility. Another cylindrical sample from the same batch APS(1) was chosen and was cut on both ends. The sample was pre-oxidized for 1000 h at 1100°C in synthetic air. Subsequently, the ends of the sample were ground with SiC paper to remove the oxide scale that was formed during oxidation and the sample was attached to the acoustic emission system and immersed in water as the other sample. A photograph of the sample and the acoustic emission signal recorded is shown in figure 9. Only very little acoustic emission was recorded over the observation time of about 900 hours. This indicates that the acoustic emission on the first sample (cf. fig. 8) was mainly from the exposed oxide scale at the upper end of the sample. Furthermore, this could be an indication that water inward diffusion through the APS TBC is very slow and since water has only limited access to the TGO layer the mechanism of moisture induced spallation is prevented.

Uncoated end
 immersed.
Oxide scale not
 removed
 before immersion!

Recorded acoustic emission from pre-oxidized sample (1100 $^{\circ}\text{C}$, 1000 h, laboratory air) during water immersion (a) and photograph of the sample during immersion. The acoustic emission increased significantly upon contact of the sample with water and decreased again after the sample was removed from the water beaker. However, the uncoated part of the sample was also immersed and microcracking in the oxide scale on this part has probably contributed to the acoustic signal. Note, no macroscopic crack was observed on the sample after immersion.

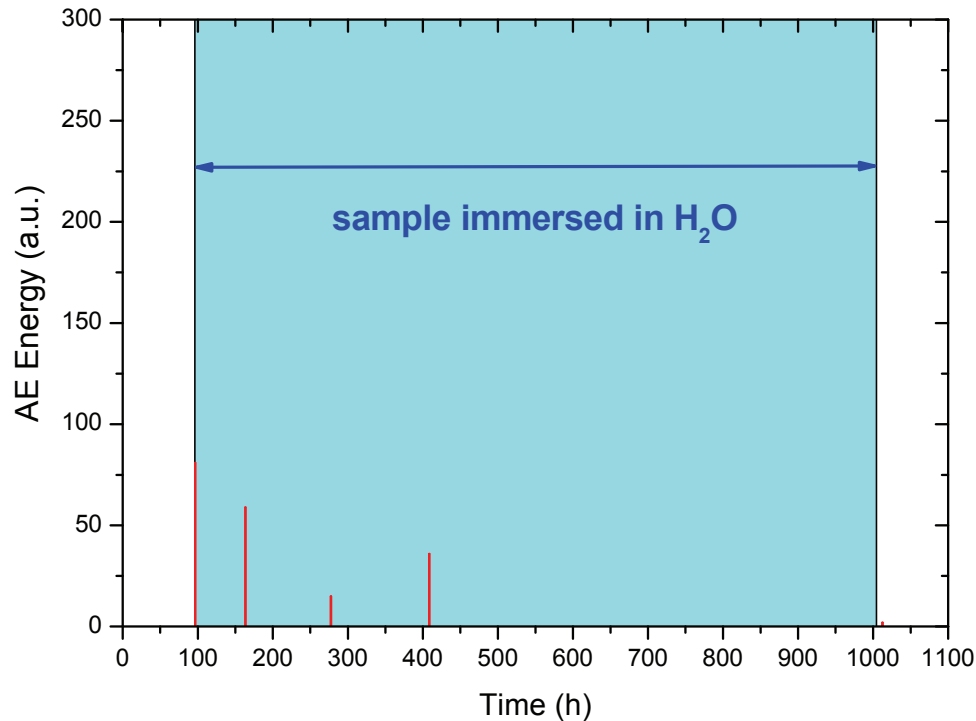
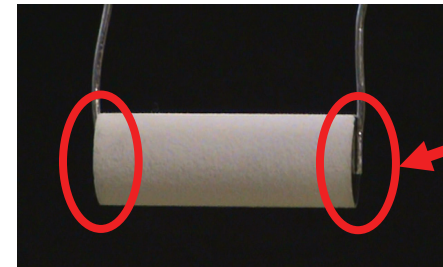
Figure 9:

Uncoated ends
immersed.
Oxide scale removed
prior to immersion!

Recorded acoustic emission from pre-oxidized sample (1100 $^{\circ}\text{C}$, 1000 h, synthetic air) during water immersion (a) and photograph of the sample during immersion. On this sample, the uncoated ends were ground with SiC paper to remove the oxide scale prior to water immersion (see photograph (b)). Only very little acoustic emission was recorded during the test with, however, higher magnitude signals were generated during water immersion. Note, no macroscopic crack was observed on the sample after immersion.

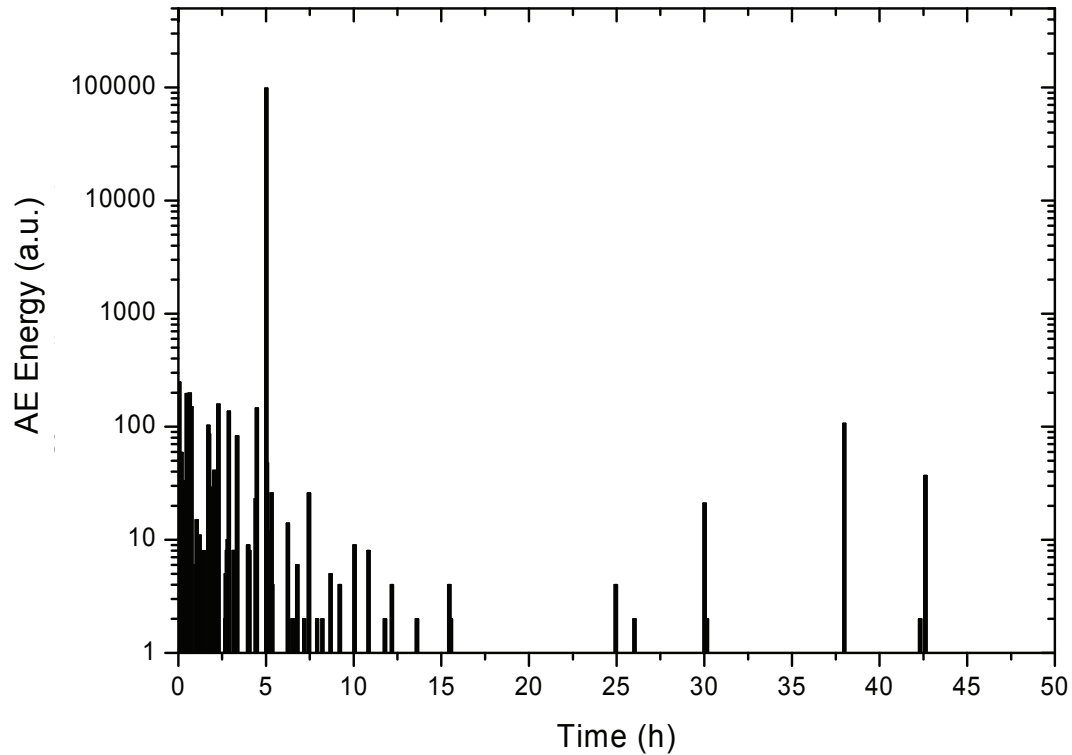
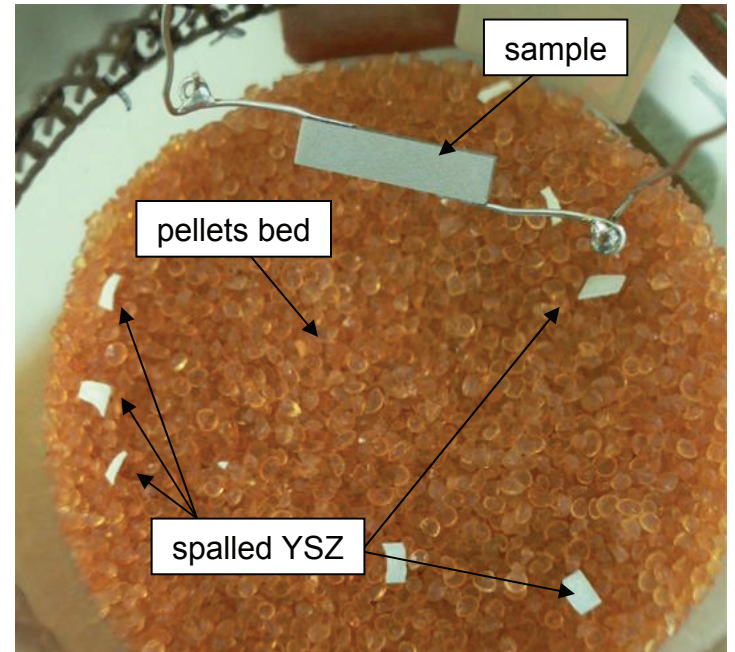
Figure 10:

A photograph of the EB-PVD sample stored in dry environment is given in figure 10 together with the acoustic signals; the corresponding sample in humid environment is displayed in figure 11. Both samples were oxidized in laboratory air at 1050°C for 190h and placed in the reactor crucibles about 30 minutes after they were removed from the furnace at high temperature. Surprisingly, both samples spalled over night as can be seen in the respective photographs. However, there is a slight difference in the way the top coating delaminated and fractured. The sample in the dry environment spalled into small pieces (visible on the bottom of the reactor crucible) whereas the sample in the humid environment delaminated as one YSZ piece. This indicates that the delamination and spallation process in the dry environment was not continuous and that the stored strain energy was just below the critical value for dry fracture. A small amount of residual water might have been in the porous structure (either from oxidation in laboratory air or from handling in laboratory air after oxidation) acting as a crack starter mechanism for subsequent unstable multiple crack growth.

Acoustic emission of 190 h pre-oxidized EB-PVD sample (1050 °C, laboratory air) and photograph of the sample after spallation. The sample was cooled from 1050 °C to room temperature within 10 minutes, then connected to acoustic emission waveguides and stored in a reactor vessel partly filled with molecular sieve pellets to create a dry environment. Nevertheless, the sample spalled over night into small pieces.

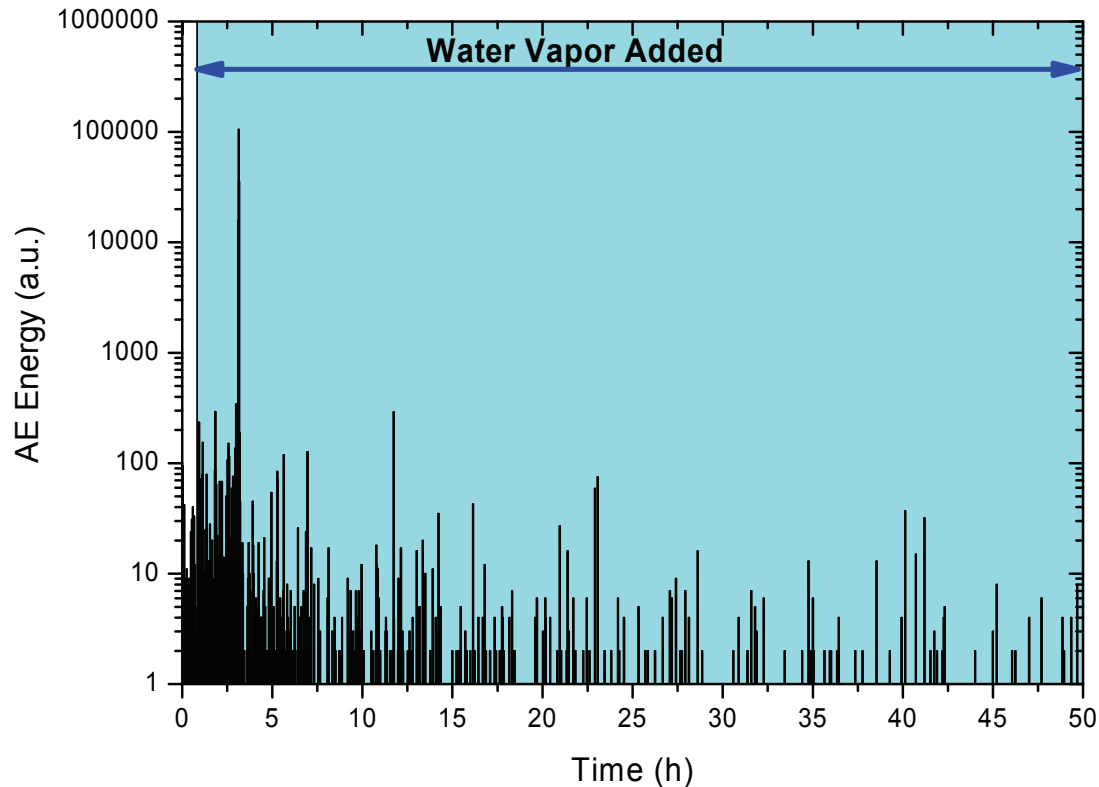
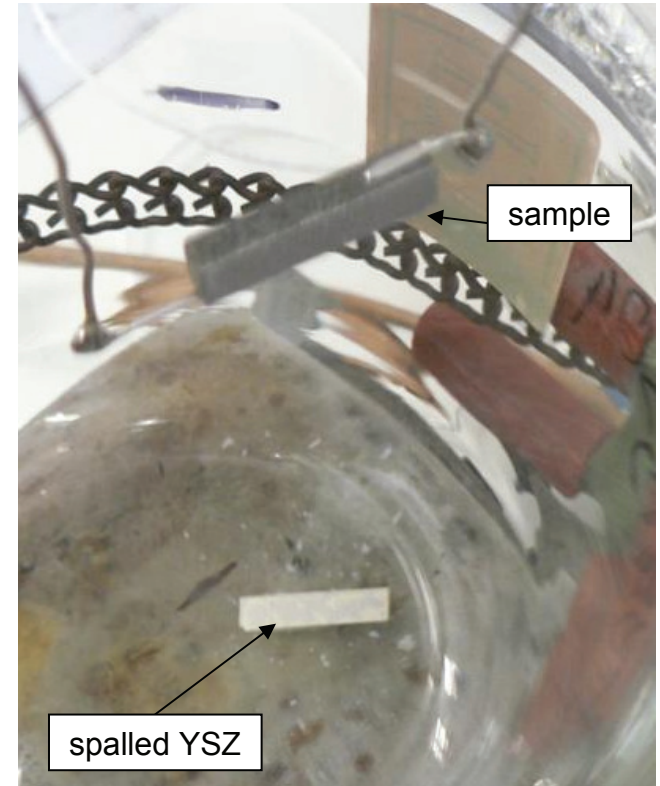
Figure 11:

In the humid environment on the contrary more water molecules were available. This led to a more continuous and stable crack growth rate resulting in a gentler release of the stored energy; which in the end was responsible for the YSZ top coating to stay in one piece.

Acoustic emission of 190 h pre-oxidized EB-PVD sample (1050 °C, laboratory air) and photograph of the sample after spallation. The sample was cooled from 1050 °C to room temperature within 10 minutes, then connected to acoustic emission waveguides and stored in a reactor vessel placed on a hot plate at about 50°C. Few water drops were added and the chamber was hermetically sealed to create a humidified environment. The sample spalled overnight, the YSZ top layer remained in one continuous piece.

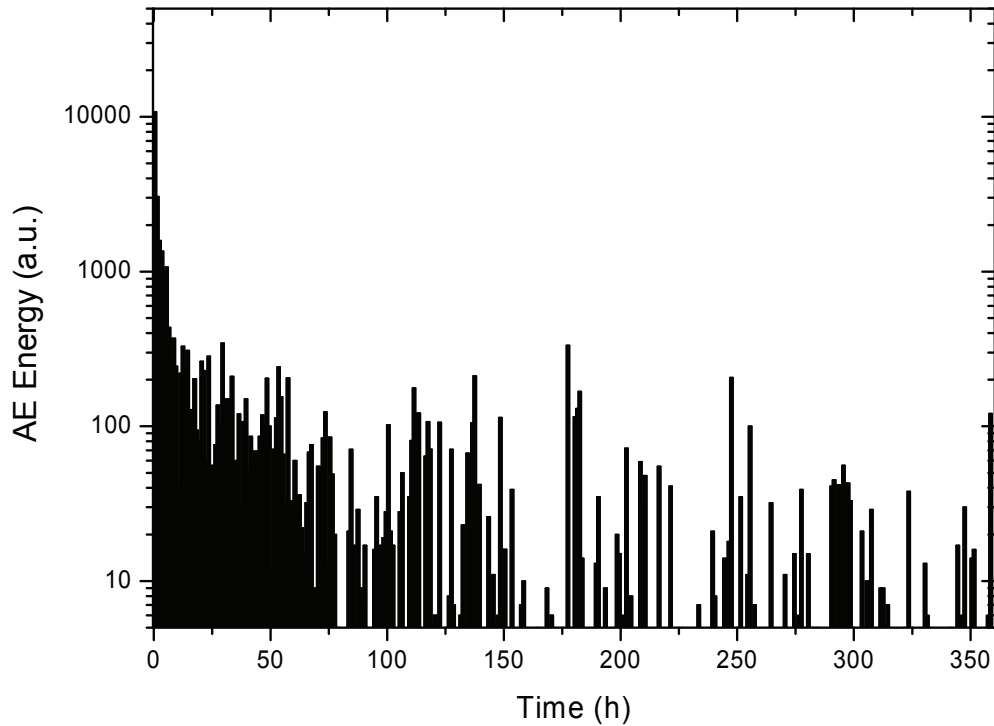
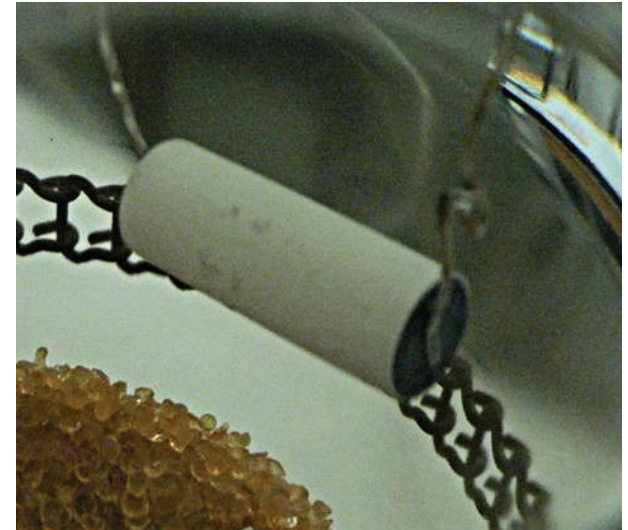
Figure 12:

Condition (3): isothermal oxidation in laboratory air at 1100°C and succeeding storage in dry air (i.e. in an exsiccator) at room temperature. Under this condition no DTS was observed on the APS(1) sample (section 3.3.6, figure 12) since no sufficient amount water vapor was present during the post-oxidation storage. However, delayed spallation was observed on the EB-PVD coated sample (section 3.3.6, figure 10), probably due to very small amounts of water vapor from the laboratory environment that had entered the TBC structure between removal from the furnace and placement in the dry air container. Furthermore, the columnar structure of the EB-PVD YSZ is more brittle than the splat structure of APS coatings, where the overlapping and interlocked splats form a more sturdy top coating.

No macroscopic cracks after 360h of
AE-testing in dried laboratory air

Acoustic Emission signal of pre-oxidized APS sample (910 h at 1100 $^{\circ}\text{C}$) after cooling to room temperature and placing in closed reactor vessel filled with molecular sieve pellets to create a dry environment. Cooling to RT and placing in the reactor vessel took about 30 minutes. The sample remained intact for the total observation duration of 360 hours and produced significantly fewer acoustic emission than the sample stored in humid environment (see figure 9).

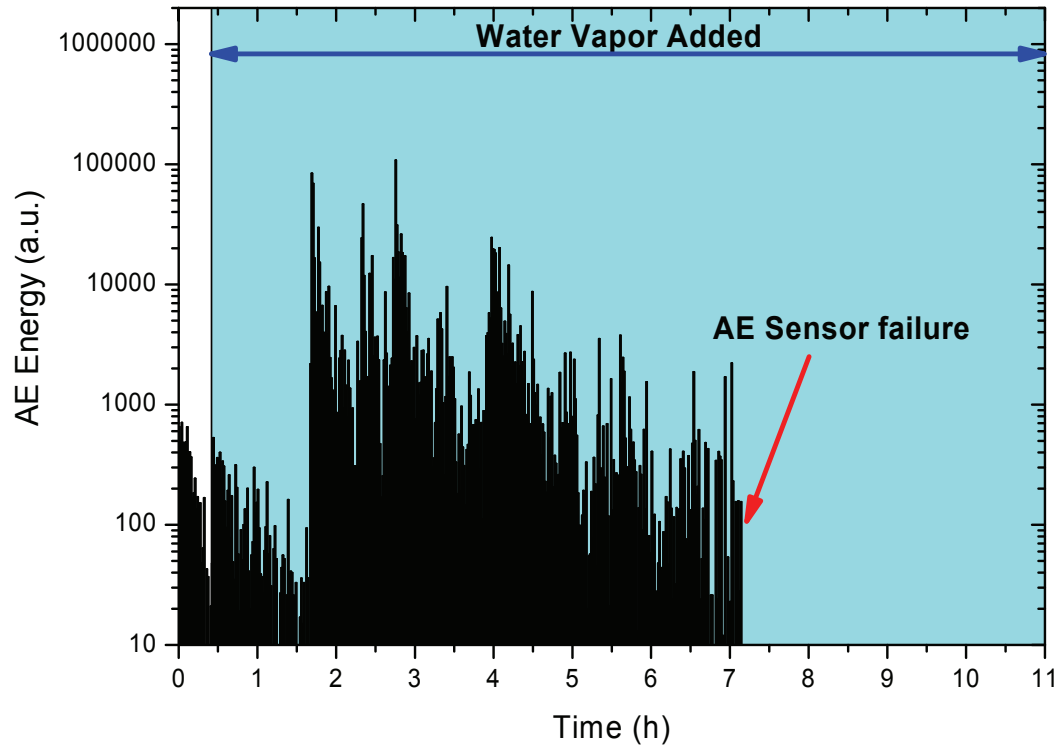
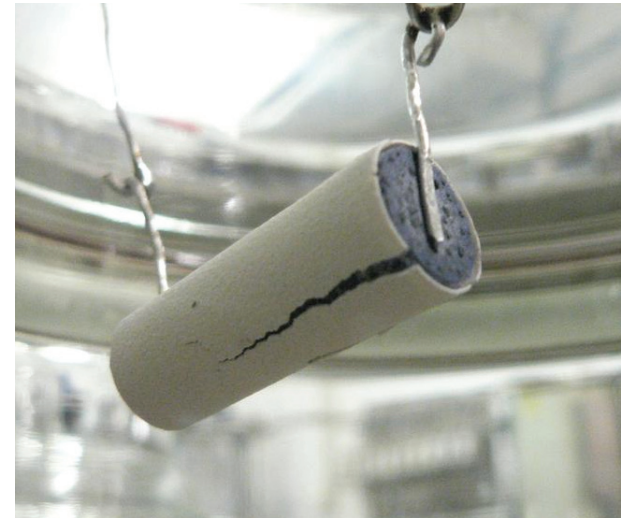
Figure 13:

Acoustic emission of 910 h pre-oxidized APS sample (1100 $^{\circ}\text{C}$, laboratory air) and photograph of the sample after spallation. The sample was cooled from 1100 $^{\circ}\text{C}$ to room temperature within 10 minutes, then connected to acoustic emission waveguides and stored in a reactor vessel placed on a hot plate at about 50 $^{\circ}\text{C}$. Few water drops were added and the chamber was sealed hermetically to create a humidified environment. The sample spalled overnight. Note, the acoustic emission sensors failed after about 7 hours due to a PC crash.

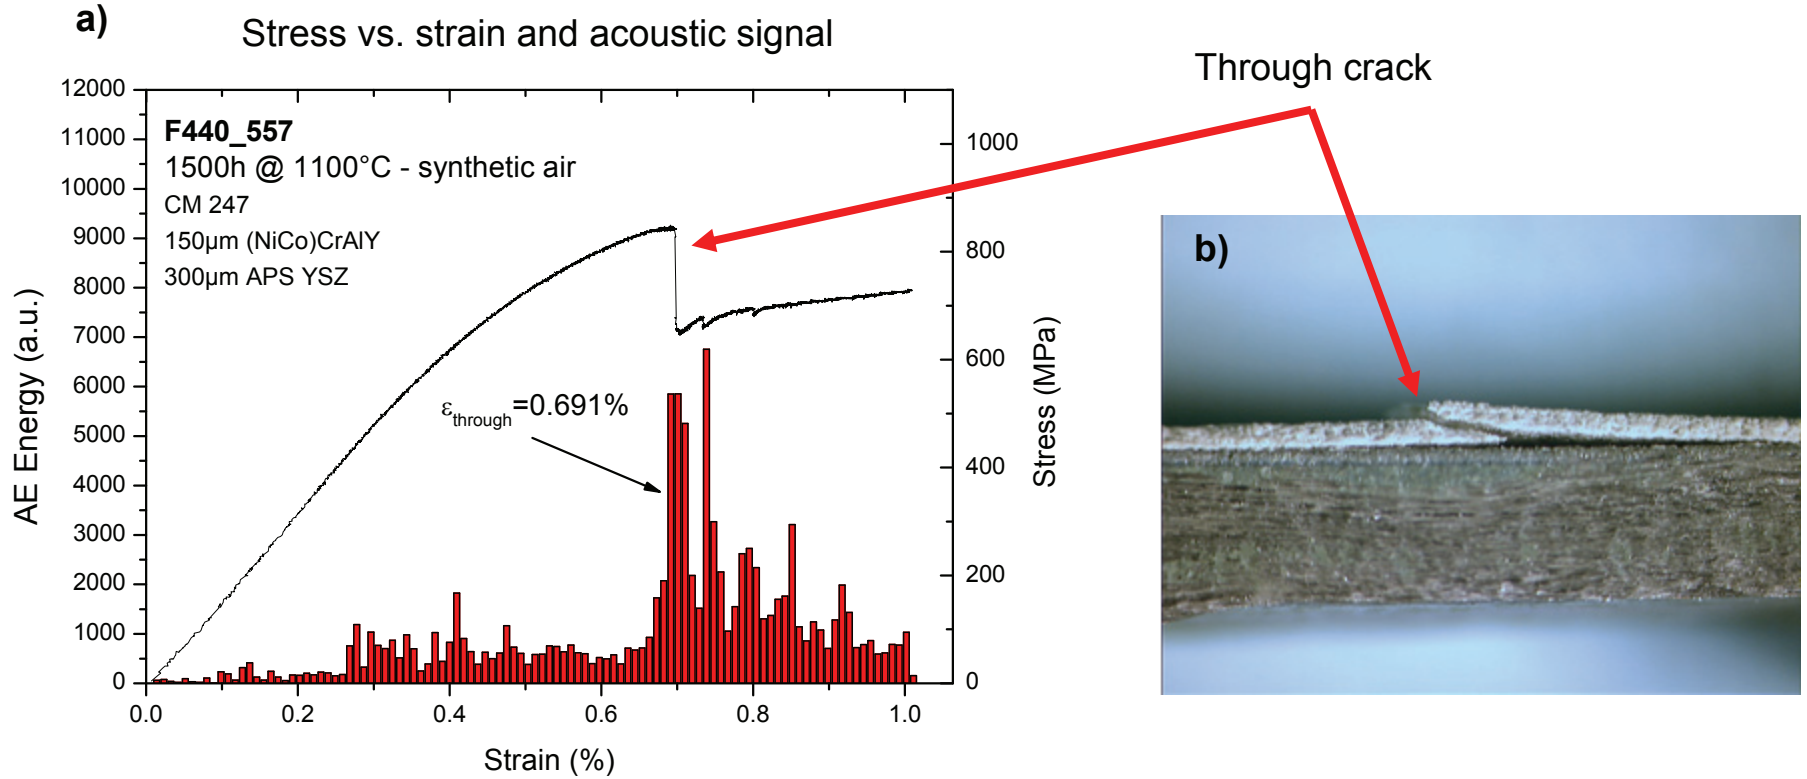
Figure 15:

Acoustic emission signal and stress/strain curve as derived from mechanical 4 point bend testing (a). The acoustic signal increases when the through-TBC crack develops and the stress drops drastically upon cracking of the TBC. Optical micrograph of TBC specimen after 4 point bend testing (b) showing through-TBC crack and partly delaminated TBC.
