VANTOM: Vanadium induced corrosion of boiler in partial oxidation process

M. Schmahl, X. Montero, C. Beyer, M. C. Galetz
e-mail: mathias.schmahl@yara.com
Funded by: BmBF via PtJ
Period: 01.03.2013 – 29.06.2016

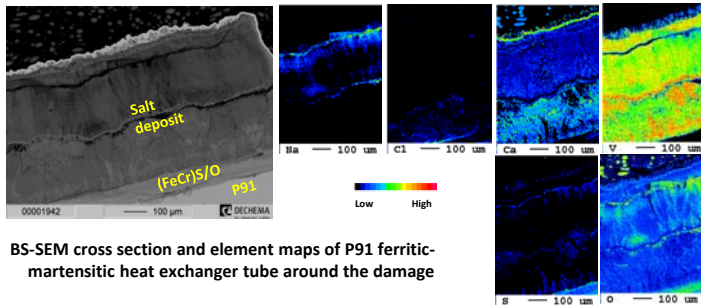
In the area where the hole is produced a combined effect of sulfidation and molten vanadate corrosion is observed. The corrosion product is a three layered structure formed by CrS on the bottom, FeS in the middle, and a (Ca,Na)-(P,V,Cl) oxide on top, which contains Fe dissolved from the FeS layer.

BS-SEM cross section and element maps of P91 ferritic-martensitic heat exchanger tube around the damage

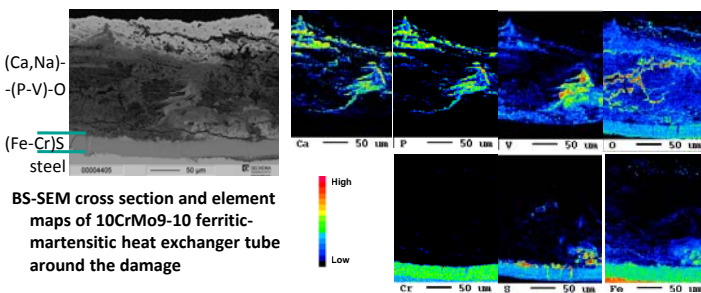
BS-SEM cross section and element maps of 10CrMo9-10 ferritic-martensitic heat exchanger tube around the damage

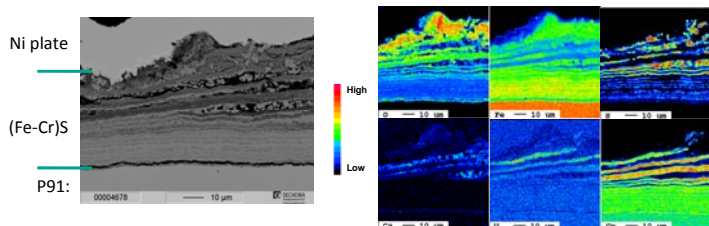
Not far from the position where the hole is produced also spots are found without deposit where sulfidation is detected as main corrosion issue. The corrosion produces a multiple layered structure which combines successively FeS and CrS.

BS-SEM cross section and element maps of the P91 ferritic-martensitic heat exchanger tube at 1 m distance of the hole/damage in the direction of the tube

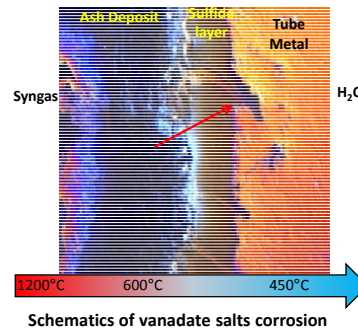
Schematics of vanadate salts corrosion

- NaCl combination is the most corrosive case. Active oxidation is the corrosive mechanism. Intergranular attack and evaporation of substrate elements increase the metal recession.
- The sulfate-vanadate hot corrosion is predominantly determined by the acid-basic constituents (Na₂O, V₂O₅ and SO₃). Pit formation increases with addition of Na₂SO₄. The main corrosion mechanism is the sulfidation followed by the dissolution and precipitation of oxide in the salt deposit.
