Abschlussbericht DFG-Re 2653/1-2

1.3	Institut/Lehrstuhl	Karl-Winnacker-Institut der DECHEMA e.V. Theodor-Heuss-Allee 25 D-60486 Frankfurt am Main
1.4	Aus DFG-Mitteln bezahlte wissenschaftliche Mitarbeiter/ innen mit Angabe des Beschäftigungszeitraums	Dr. M. Rudolphi 01.02.2007 - 31.01.2009

1.5	Thema des Projekts	The Role that Hydrogen and Sulfur Play in Desktop Failure of Thermal Barrier Coatings
1.6	Berichtszeitraum Förderzeitraum insgesamt	01.02.2007 - 31.07.2009 01.02.2007 - 31.07.2009

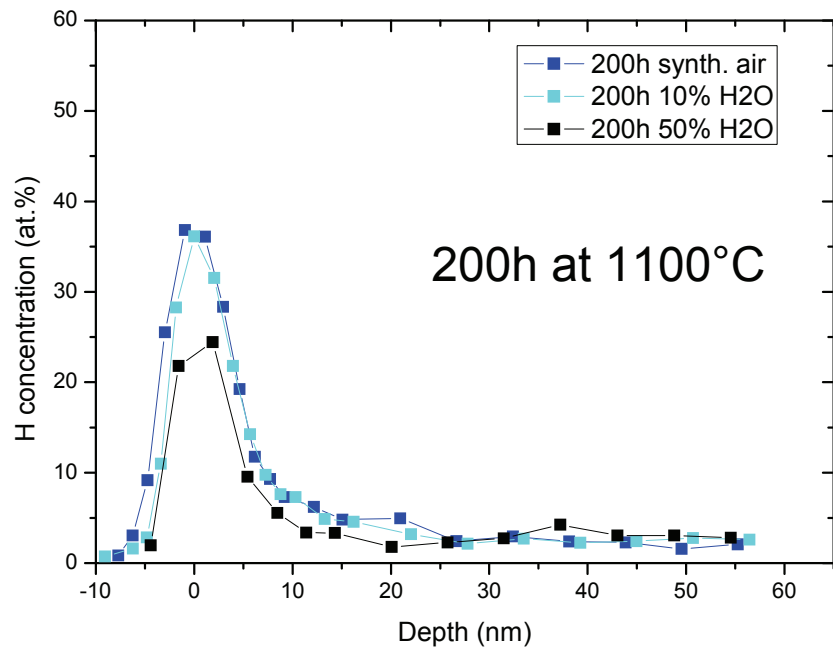
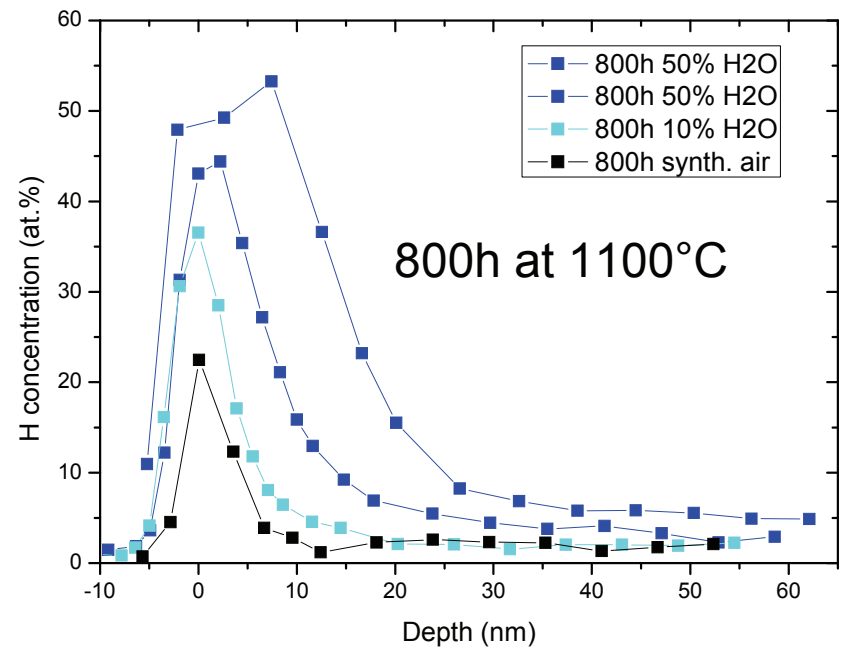
Figure 2:

Hydrogen concentration depth profiles of the TBC top surface after 200 h and 800 h oxidation, respectively, at 1100 °C in different atmospheres. While the depth profiles of the samples oxidized for 200h look rather similar, after 800 h a strong increase in H-concentration at the surface and into the YSZ coating can be observed.

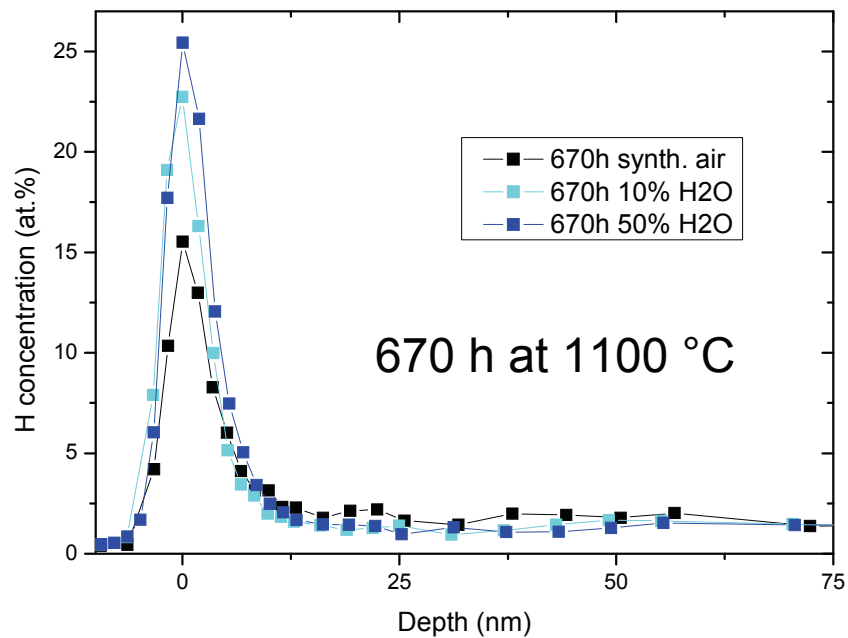
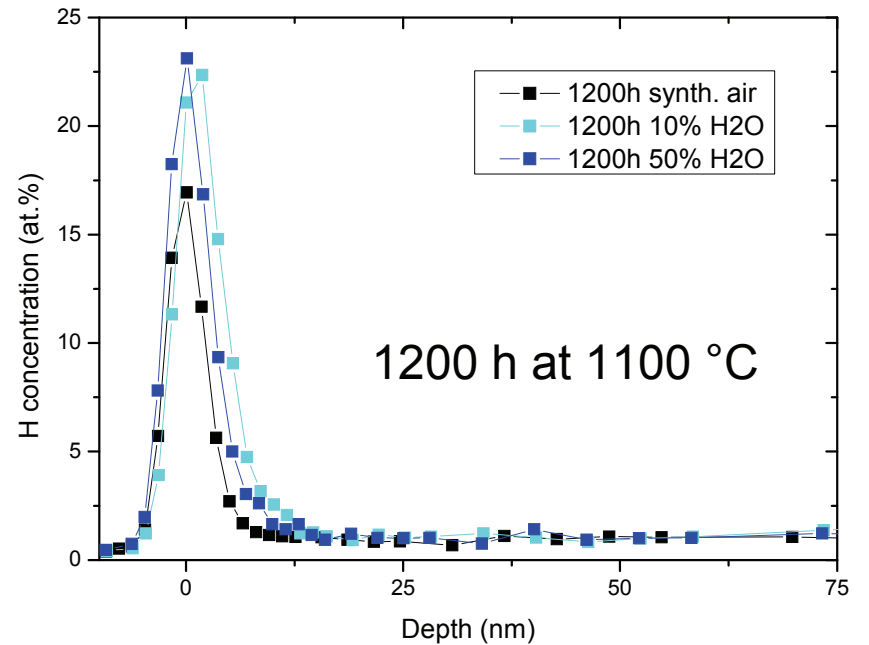
Figure 3:

Hydrogen concentration depth profiles of the exposed delamination surface after forced spallation under vacuum. Comparable amounts of hydrogen are detected which are superimposed by contamination with absorbed carbohydrates from the residual gas. Hydrogen levels from specimens oxidized in humid environment seem slightly higher.

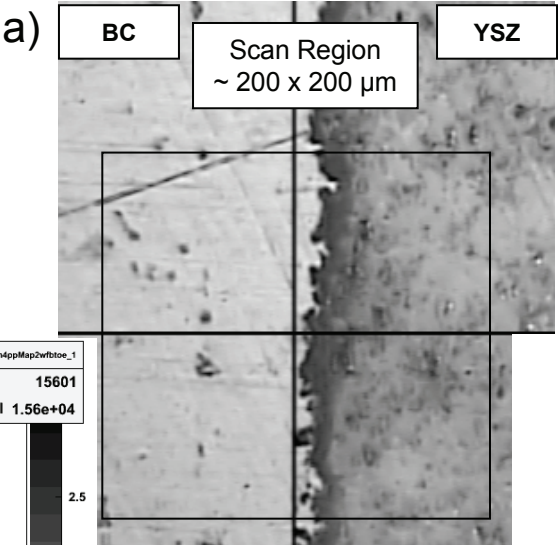
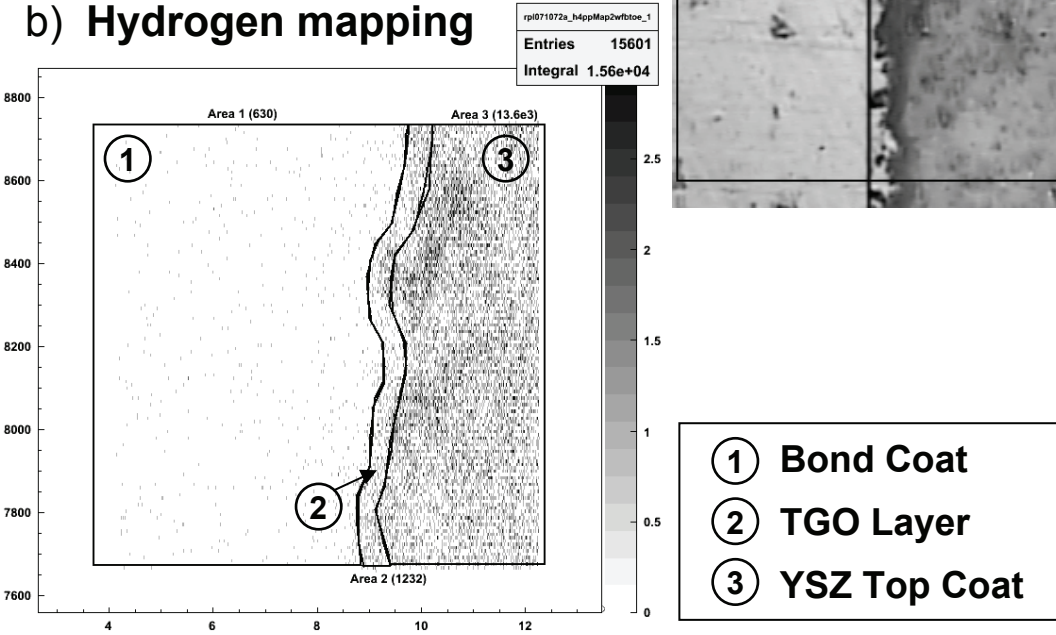
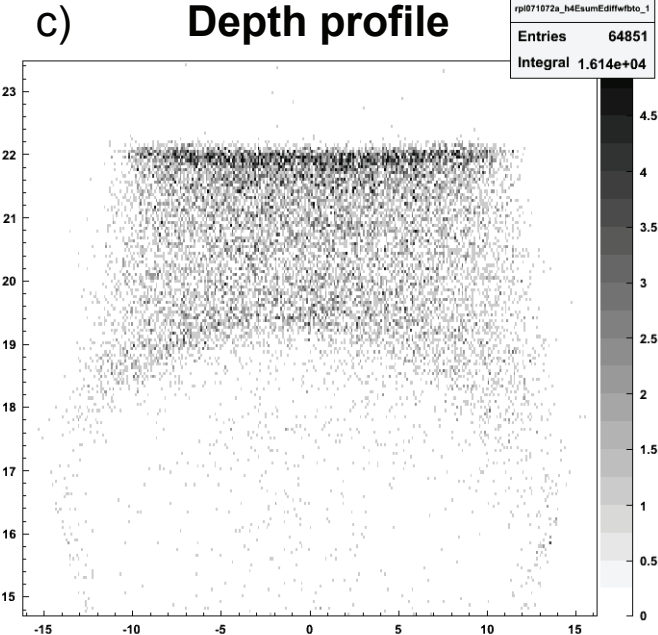
Figure 4:

Optical image of the thinned TBC cross section (a) prepared for NRA-PT measurement showing the scan region (~200 x 200 μm²). The APS(2) sample was oxidized at 1100°C for 800h in synthetic air & 10vol.% H₂O. The hydrogen mapping generated from the measurement data (b) as integral over the total thickness of cross section and hydrogen depth profile of thinned TBC cross section (c) calculated over the whole scan area. Both surfaces in the depth profile show higher hydrogen amounts (i.e. they appear darker) due to absorbed water/hydrogen, the lower surface appears bent due to proton energy loss in the sample.

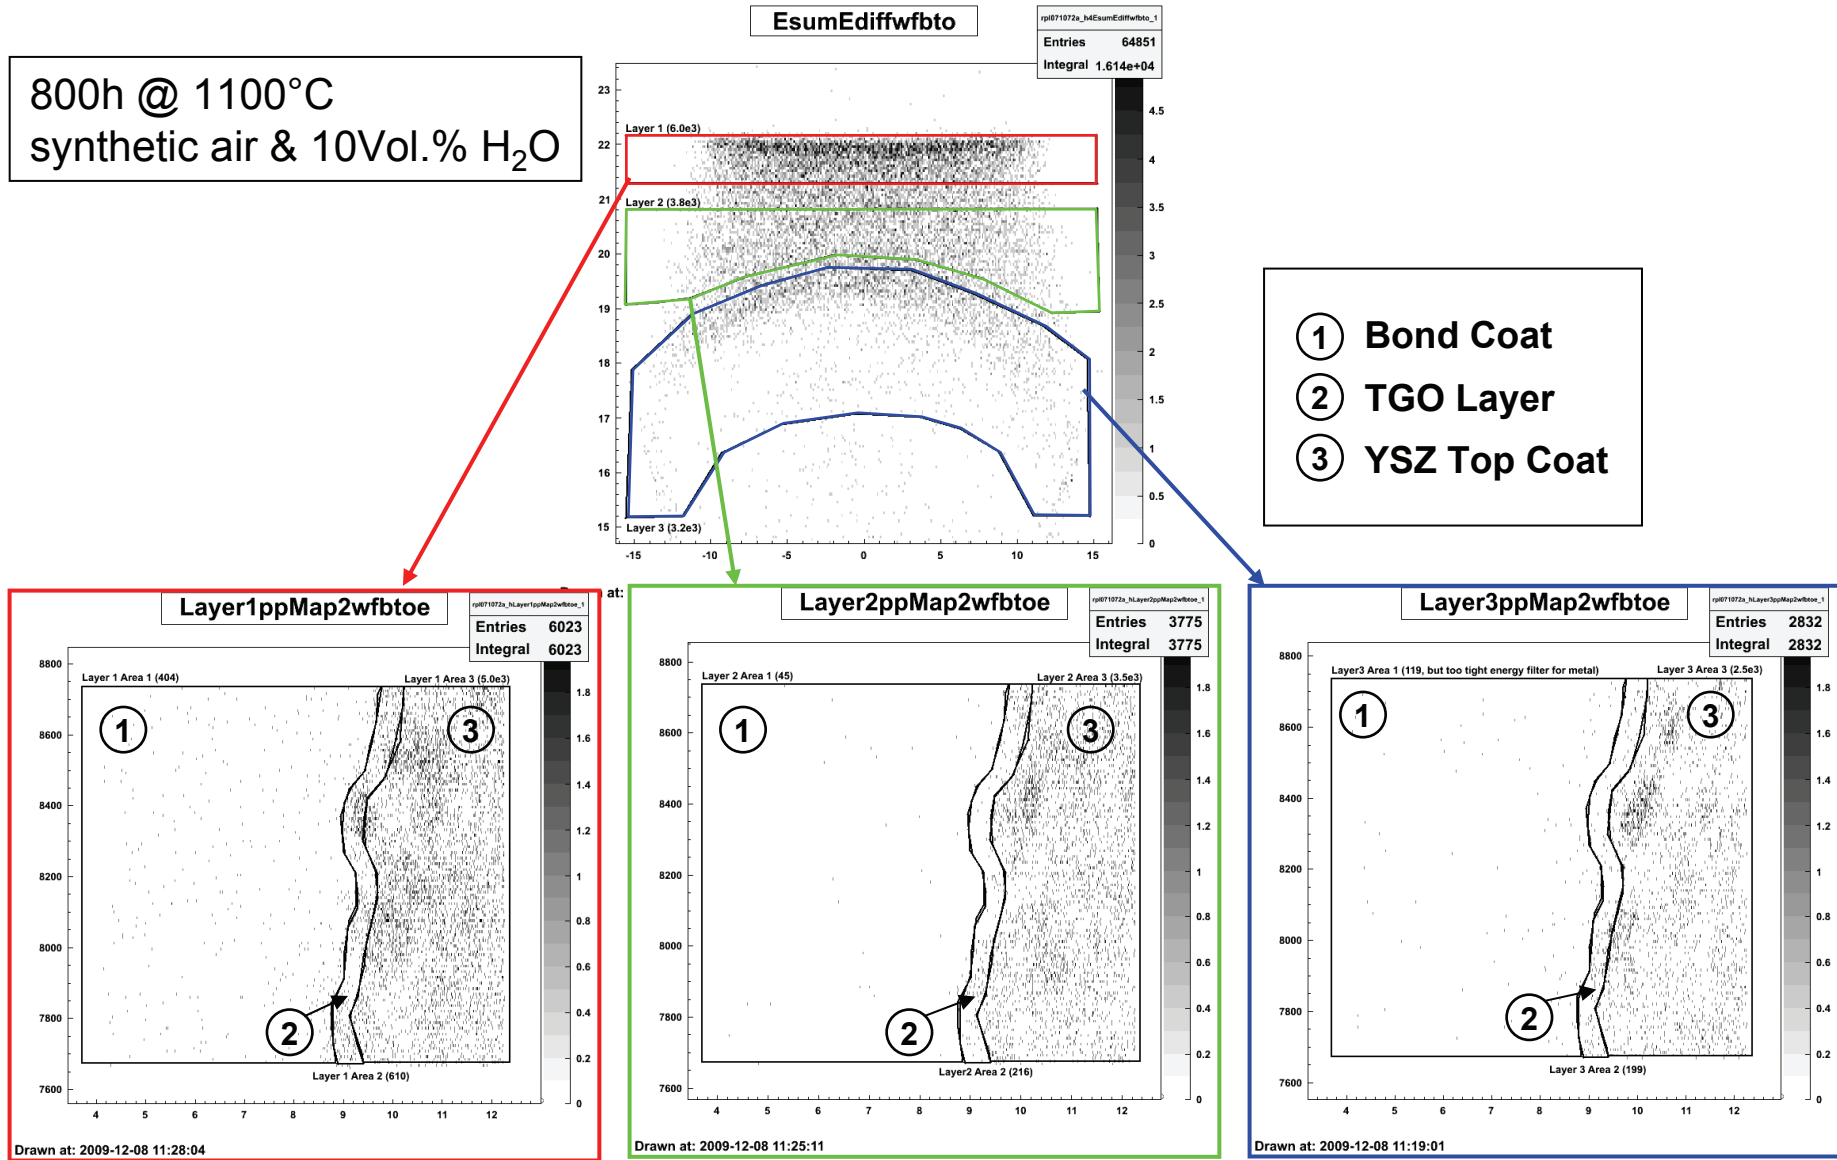
Figure 5:

Figure 5 is a detailed analysis of the depth profile given in figure 4c and provides hydrogen mappings of different depth regions in the cross-section. The red and blue mappings were calculated from the surface regions and the green mapping is an approximation of the inner

Hydrogen mappings generated from different depth regions of the thinned TBC cross section. Upper surface (red) and lower surface (blue) are superimposed with absorbed water/hydrogen. A restriction to the inner volume of the cross section is given in the green mapping. Some areas show slightly increased hydrogen concentrations, however, no clear correlation with the TGO/bond coat or TGO/TBC interface can be seen. Hydrogen is almost evenly distributed within the YSZ and TGO layer.

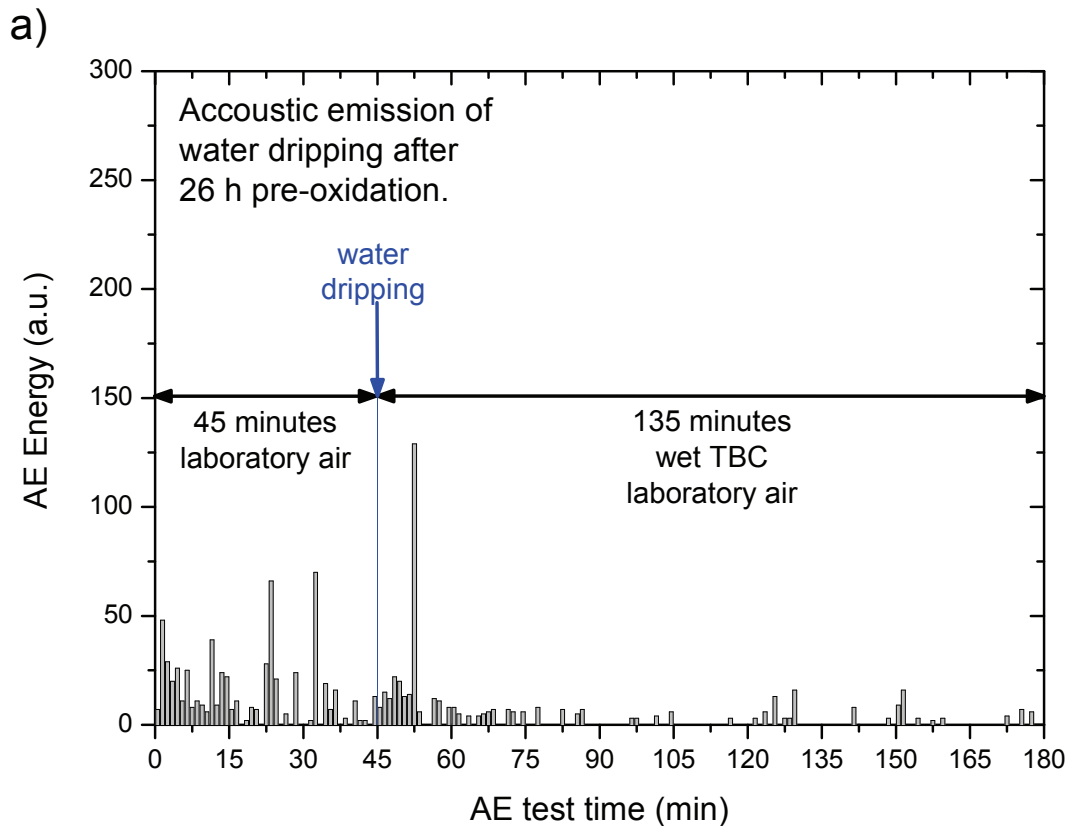
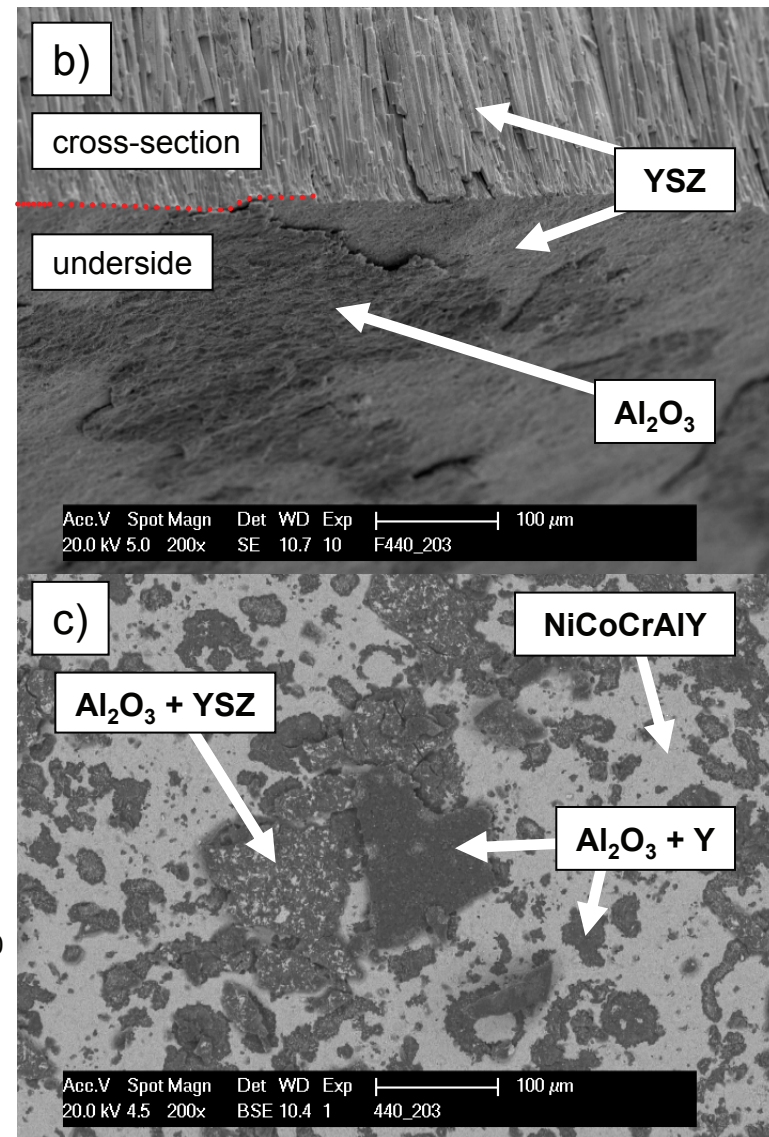
Figure 7:

Acoustic emission of EB-PVD sample pre-oxidized for 26 h at 1050 °C (a). The sample was quenched to room temperature prior to connecting the AE sensors and monitored for 45 min before water was added. No spallation was observed, however, a slight increase of acoustic emission can be seen at the time where water was dripped on the coating.

SEM micrographs taken from the sample that exhibited water induced spallation (figure 5). The delaminated TBC (b) and the delamination surface of the substrate (c) show that the failure locus is both above and below the TGO.

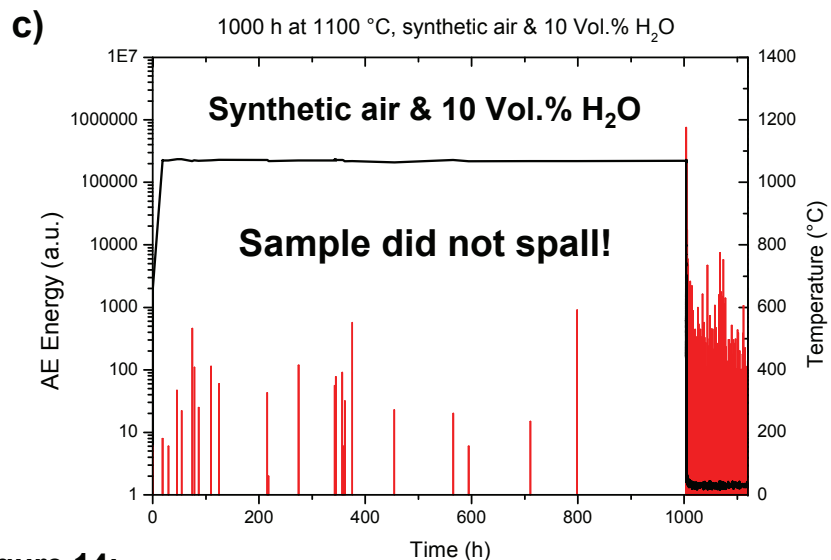
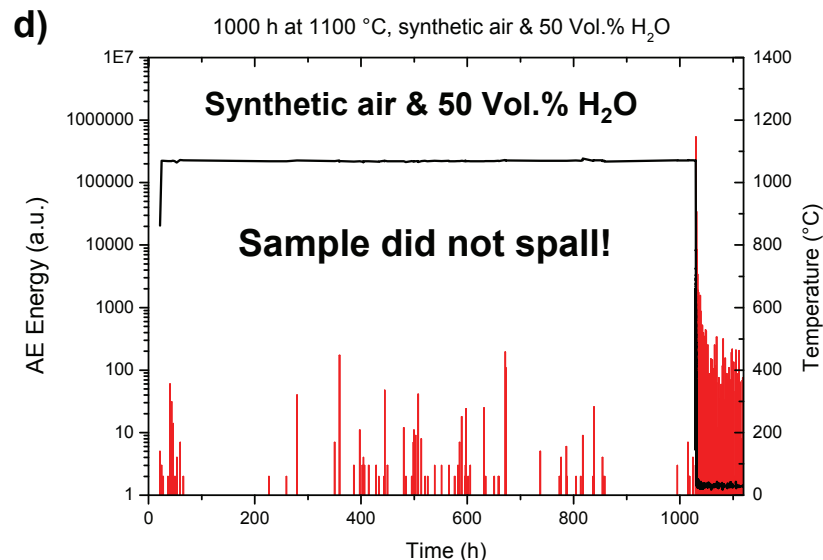
Figure 14:

The amount of cracking that occurs at high temperatures was investigated in isothermal exposure experiments at 1100 °C in three different atmospheres, namely synthetic air, synthetic air & 10 vol.% H₂O and synthetic air & 50 vol.% H₂O. APS samples from batch APS(1) were chosen for this test. The acoustic emission data of the sample oxidized in dry synthetic air is given in figure 14a. During the whole hot dwell time of 1000 h only a few acoustic events were recorded. This indicates that there is no significant cracking in the sample when hot. The vast majority of acoustic emission is generated during cooling from 1100 °C to room temperature with the first events occurring at temperatures around 800 °C and the acoustic emission slowly diminishing over the following days. As can be seen in figure 14b the sample that was oxidized in dry synthetic air spalled upon cooling from high temperature, whereas the two samples oxidized in the humid environment both remained intact. The analysis of the acoustic emission from those two specimens (see figures 14c and 14d) reveals that a higher amount of micro-cracking occurs at oxidation temperature in the humid environments and that the energy release per acoustic event is also higher than in the dry environment. This high temperature micro-cracking will decrease the strain energy build-up in the TBC system and result in lower stored strain energy after cooling also. Consequently the stored strain energy was too small on those samples to cause spallation.

Acoustic signal obtained during isothermal oxidation for 1000 h at 1100 °C in the three different atmospheres. A strong acoustic signal is observed during cooling and about 150 h after the sample is at RT – independent of the oxidizing environment. Slightly increased acoustic emission is observed during the 1000 h hot dwell at 1100 °C in the humid environments. This increase could also be caused by the unprotected sides of the cylindrical samples. The sample oxidized in dry environment spalled upon cooling, the other two samples remained intact.

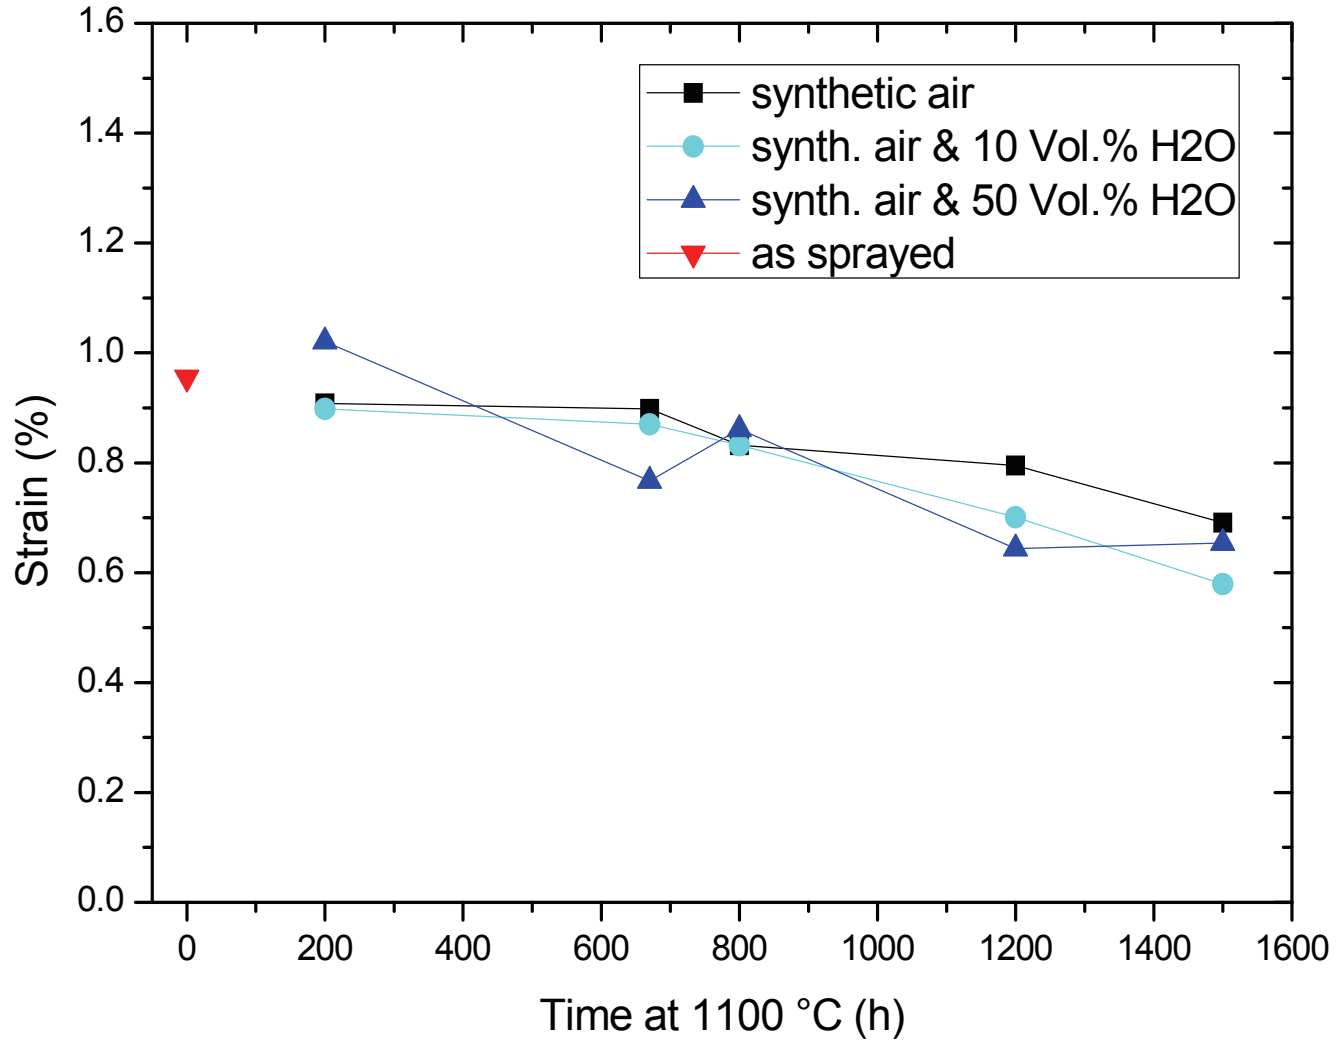
Figure 16:

The critical strain values for through cracking obtained from the different samples are given as a function of exposure time and environment in figure 16. The specimens that were pre-oxidized in humid environment show a tendency towards slightly lower critical strain values, however, the values are more or less in the same range. Since the critical strain values for through cracking obtained by this test are mainly influenced by the YSZ top coating, this indicates that the oxidation in humid environments does not lead to a significant deterioration of the YSZ compared with oxidation in dry environment.

Critical strain for through cracking derived from 4-pt. bend testing as a function of oxidation time at 1100 °C and oxidation environment. A slight tendency towards lower critical strain values can be observed for specimens oxidized in humid environment.

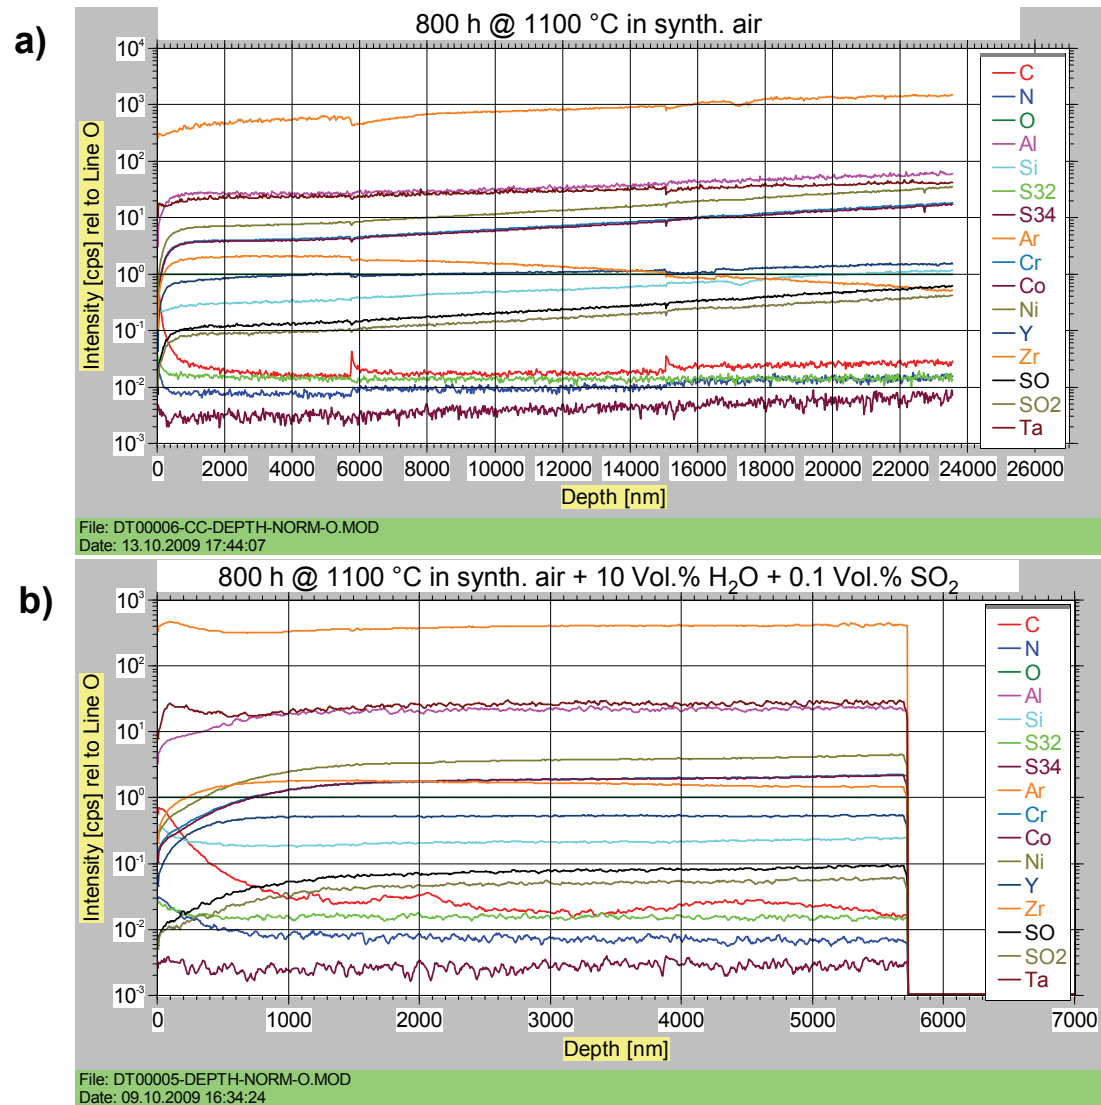
Figure 17:

The approach in part II of the project was therefore to drastically increase the available SO₂ in the oxidation environment by a factor of 10 to 0.1 vol.%; and to try another way to expose the TBC/TGO interface. The samples selected for analysis were laser-ablated using the Nd:YAG laser of the DECHEMA micro-manufacturing laboratory. The results of two samples oxidized at 1100 °C for 800 h in synthetic air vs. synth. air & 10vol.% H₂O & 0.1vol% SO₂ are given in figure 17. As can be seen, the signals for sulfur (either ³²S or ³⁴S) are not changing over the total depth range investigated and are at a very low intensity corresponding to concentrations of approximately around 0.05 at.%. No indications of an accumulation of sulfur was found, neither on the sulfur exposed nor on the synthetic air exposed sample. Obviously, no significant inward diffusion of SO₂ occurs through the APS YSZ top layer.

SNMS concentration depth profiles of specimens oxidized for 800 h at 1100 °C in synth. air (a) and synth. air & 10 Vol.% H₂O & 0.1 Vol.% SO₂ (b). No indication of sulfur accumulation in the vicinity of the TGO can be observed neither on the ³²S nor on the ³⁴S lines.

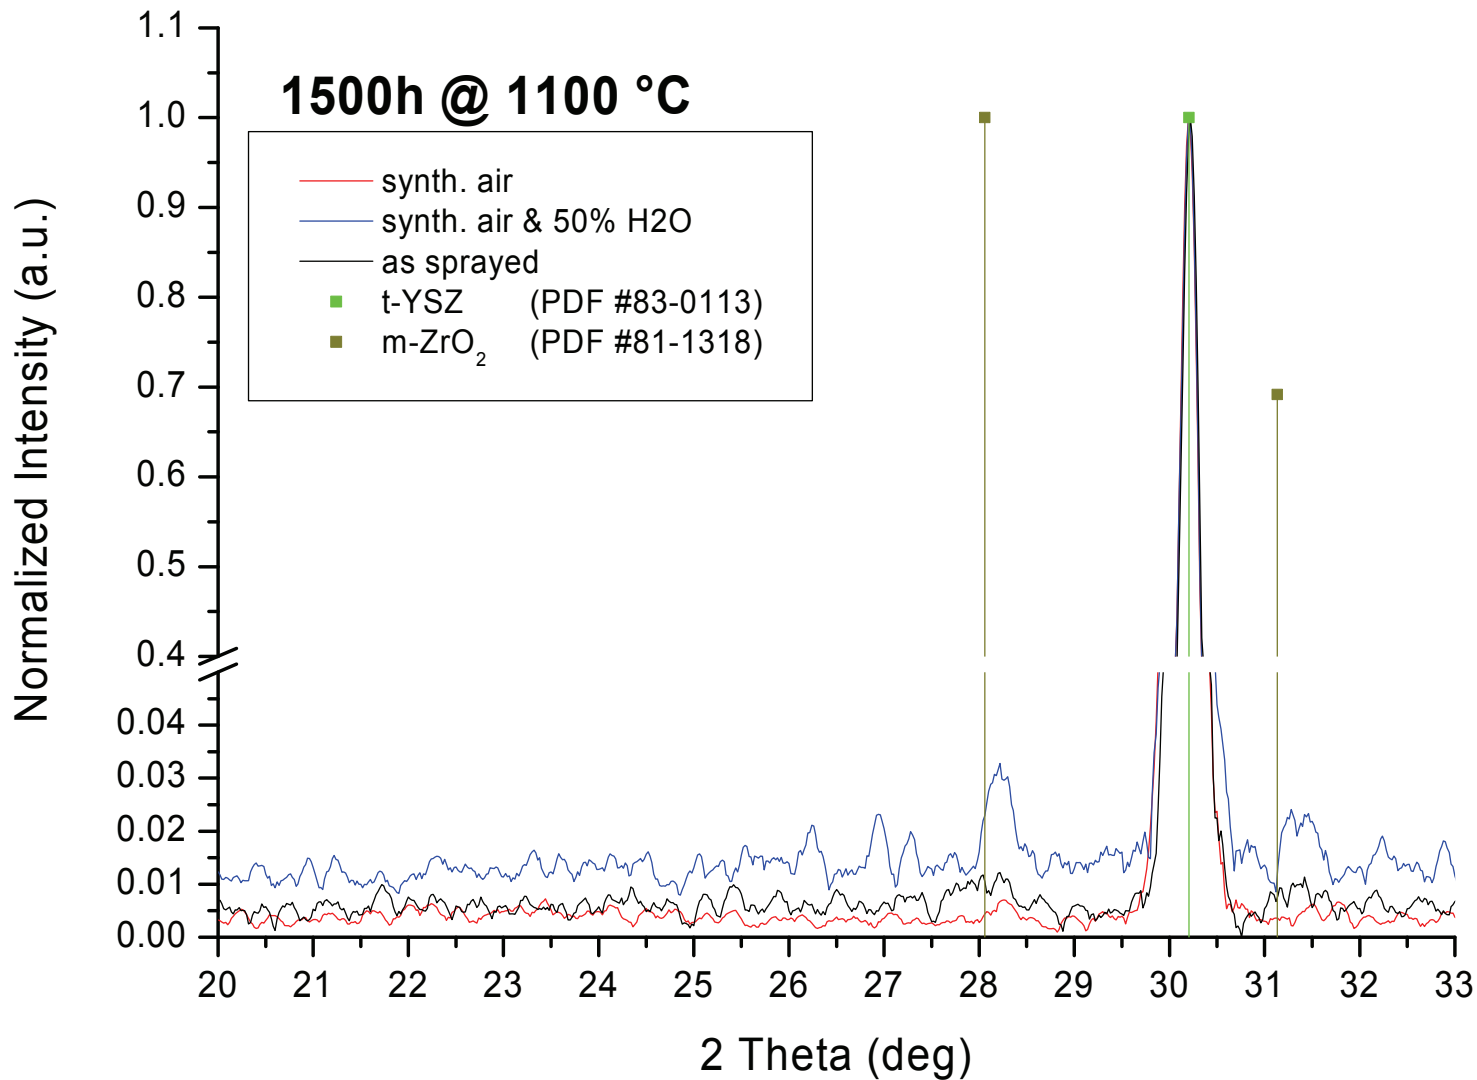
Figure 18:

XRD pattern of the top surface of oxidized APS TBC specimens in comparison with as-sprayed state. A very small fraction of monoclinic phase is present in the sample that was oxidized in humid environment, whereas the sample oxidized in dry synthetic air consists only of the tetragonal YSZ phase. Note, the spectra were normalized with respect to the highest peak for tetragonal YSZ at 30°, the peak at 28° corresponds to the highest line in pure monoclinic ZrO₂.

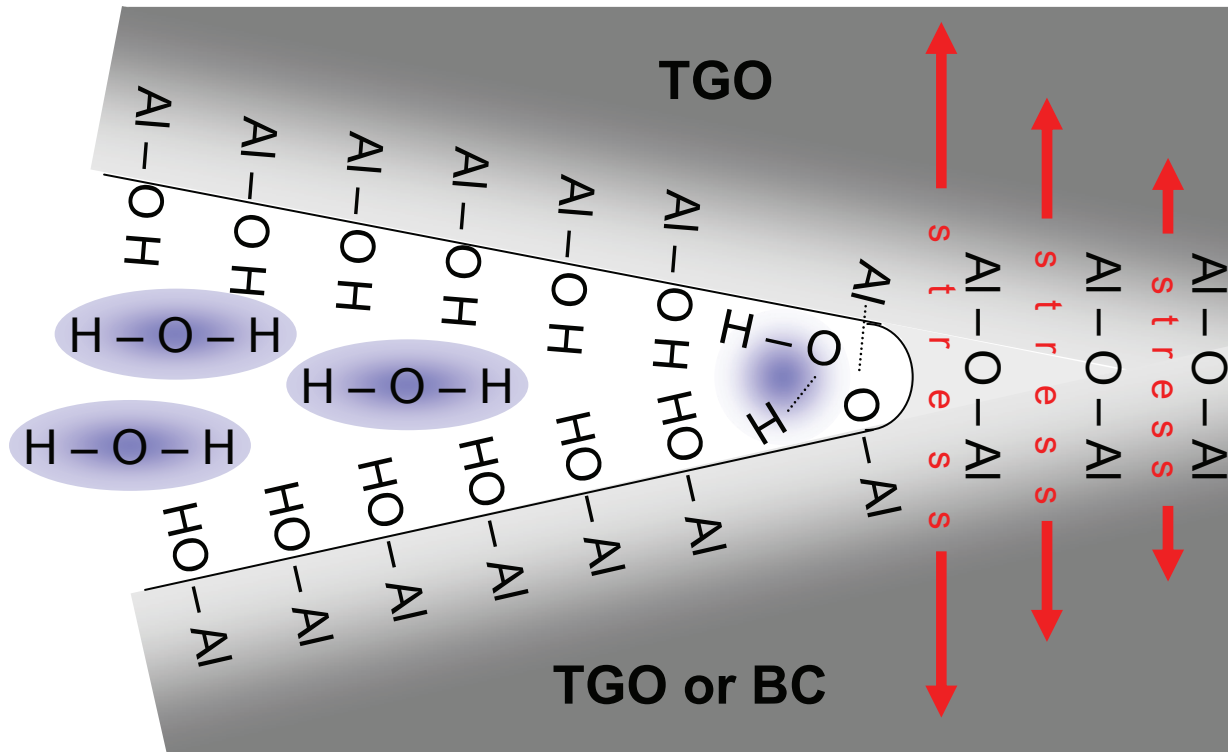
Figure 19:

Wiederhorn and Charles report increased crack growth rates in the presence of water vapor for glass and sapphire [11;12;20;21]. This would affect the TGO itself and the TGO/bond coat interface, possibly also the TGO/YSZ interface. Also, the generation of hydrogen by a reaction of aluminum powder with distilled water was observed [13] which could provide another source for hydrogen species at the TGO/bond coat interface. The released hydrogen could then enter the TGO and act according to Wiederhorn and Charles to increase crack growth rates. There is also the possibility of a degradation of the tetragonally stabilized YSZ by water which was described by Yoshimura [15]. Indeed small fractions of the monoclinic zirconia phase have been observed with XRD after oxidation in humid environment (cf. figure 18) however, since the crack path in DTS is usually along the TGO/bond coat or TGO/YSZ interface it seems more likely that the degradation of alumina is the major mechanism in DTS. Lawn provides an atomistic model of crack growth in alumina in which the strongly linking oxygen ions are replaced by weakly coupled hydroxyl pairs[10]:

Proposed mechanism for moisture induced damage and delamination. Water molecules enter the crack tip (crack in either alumina or at alumina/bond coat or alumina/YSZ interface). Mechanical stresses allow access of dissociated OH^- or H^+ to oxygen bridge to form hydroxide groups which are only weakly linked. Crack opening occurs and allows more water molecules to enter the crack tip. Crack growth can occur only as long as sufficient H_2O transport to the crack tip is ensured.

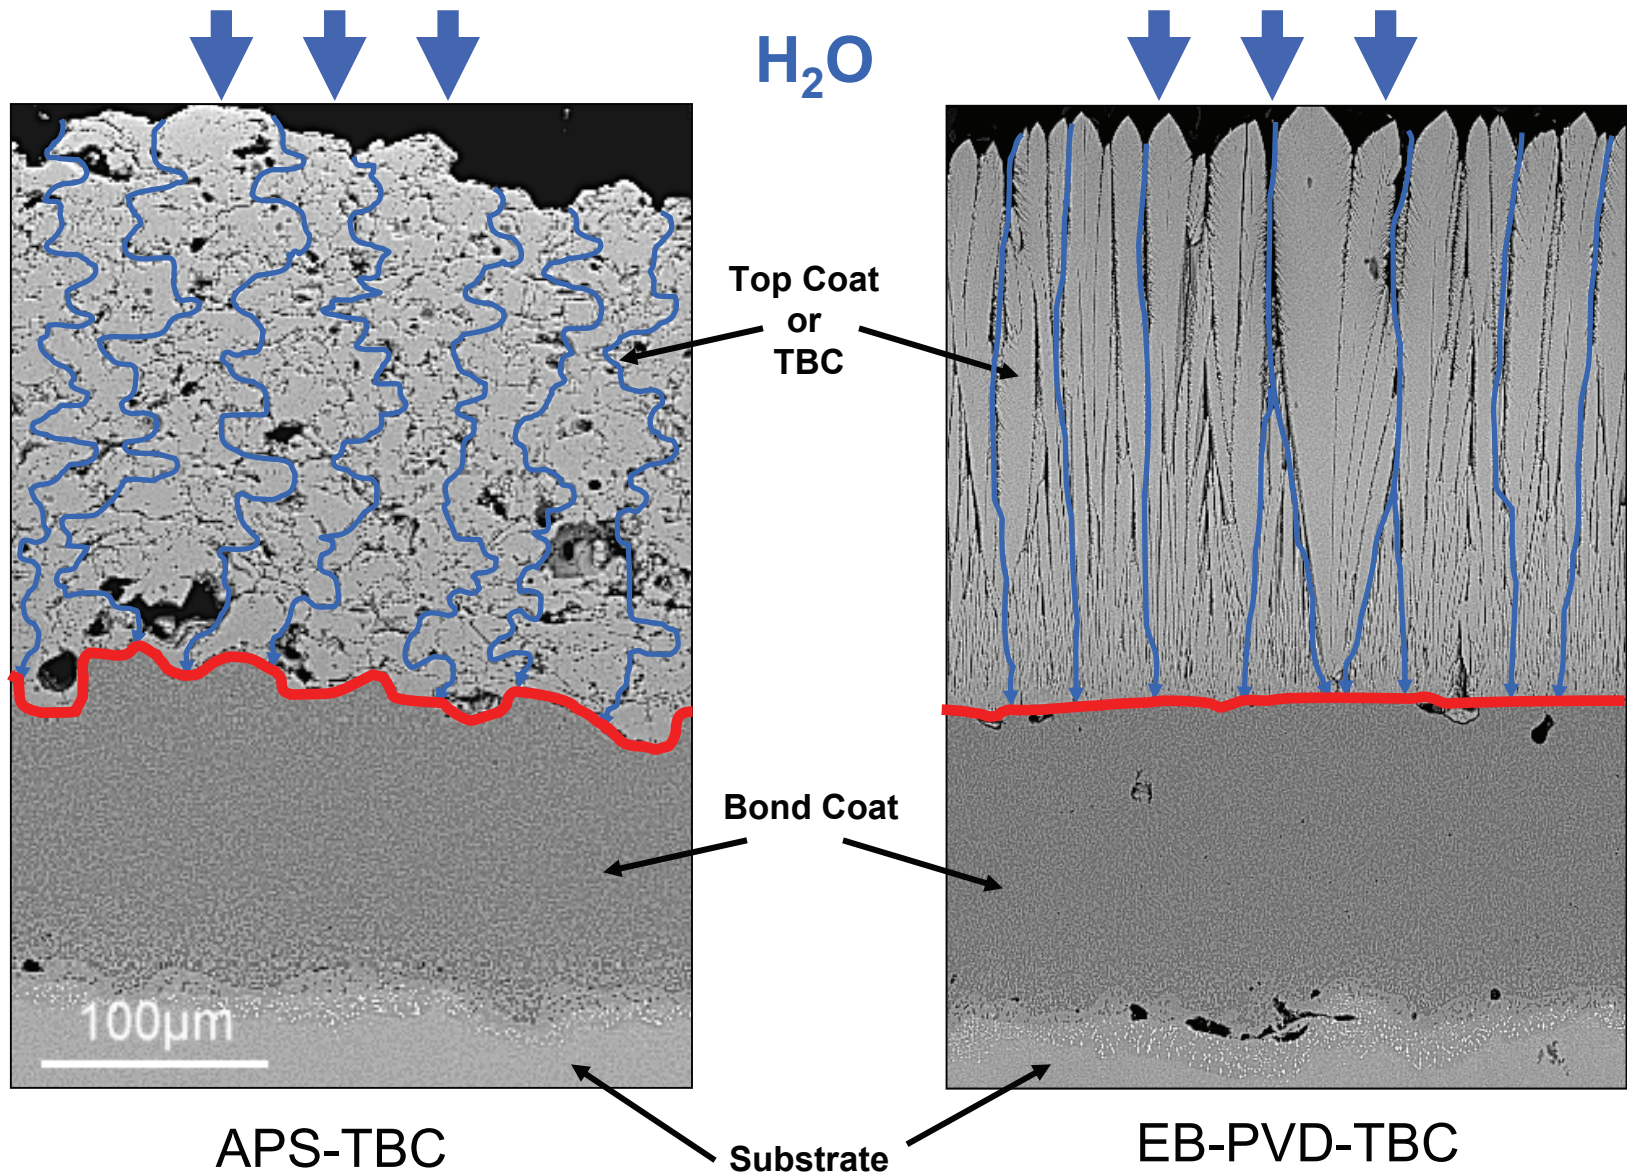
Figure 20:

The geometric condition of the TBC system is another very important factor in the failure mechanism. This becomes evident when looking at the differences between EB-PVD coatings and APS coatings and was mentioned in the discussion of the Desktop Failure Map in section 3.3.1. Figure 20 highlights the two major differences between EB-PVD and APS coatings and their impact on the DTS mechanism.

Possible diffusion pathways for water (blue lines) to penetrate through the TBC to the underlying TGO layer. Clearly the columnar structure of EB-PVD allows straight-forward diffusion along intercolumnar channels whereas the APS structure enforces diffusion along zigzagging pathways provided by the splat morphology. Furthermore the flat interface morphology (red line) in EB-PVD coatings enables a fast crack growth along an almost flat plane and results in easier spallation in contrast to the rough interface of APS coatings which leads to cracks running into the bond coat or into the YSZ.
